Troy's Home Inspection Service

Property Inspected: 5012 Woodway Court Hamburg NY 14075

Date Inspected: Fri June 28th 2013 **Time Started:** 17:28 **Time Ended:** 19:47

Home is a Single Family 2 Story Colonial with attached two car Garage and unfinished full Basement, built by Ryan Homes approximately 1 year old.

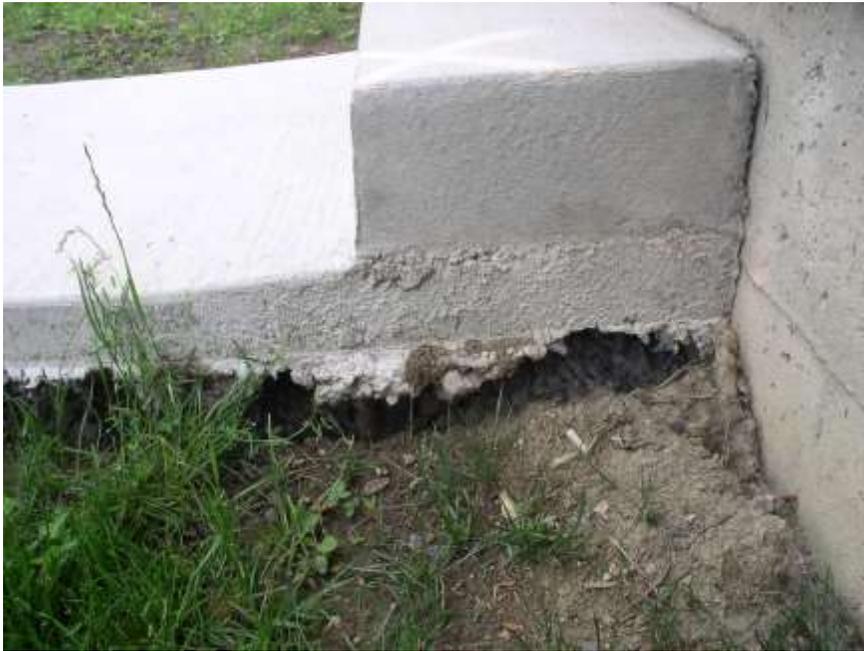
2. Attached Decks, porches and associated railings. Inspector noticed erosion of soil under concrete slabs and separation chipping of slabs from porch. (See Picture 1) Also noted was openings on either side of front porch which could allow vermin into the openings. (Picture 2)Recommend having these items checked by a qualified masonry contractor.

6. Grading, surface drainage, as noted above some erosion noted under front walkway slabs, otherwise a satisfactory rating.

Picture 1. Erosion under walkway slab

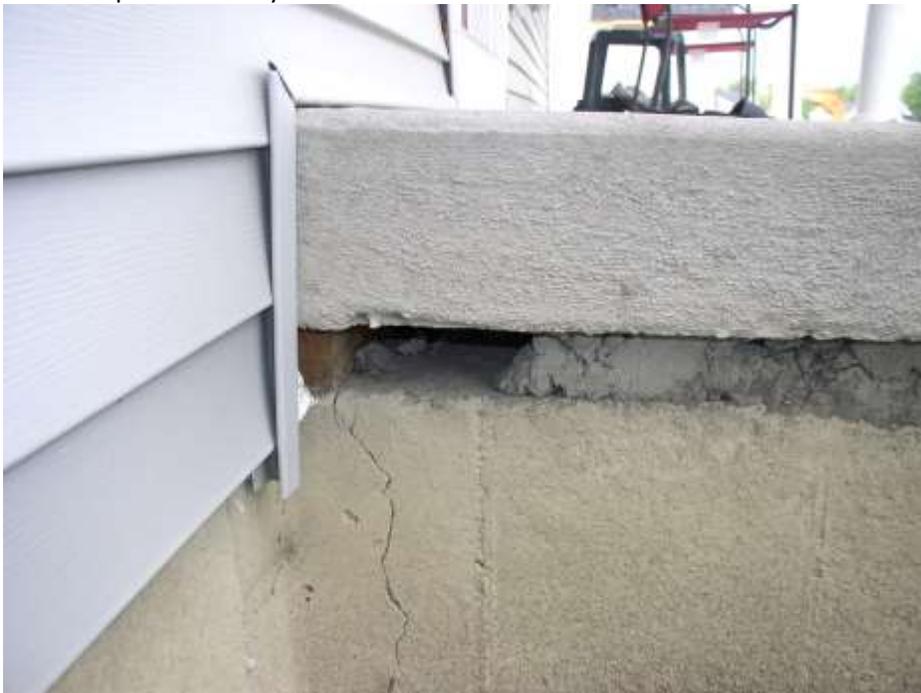
Picture 2 possible entry for vermin

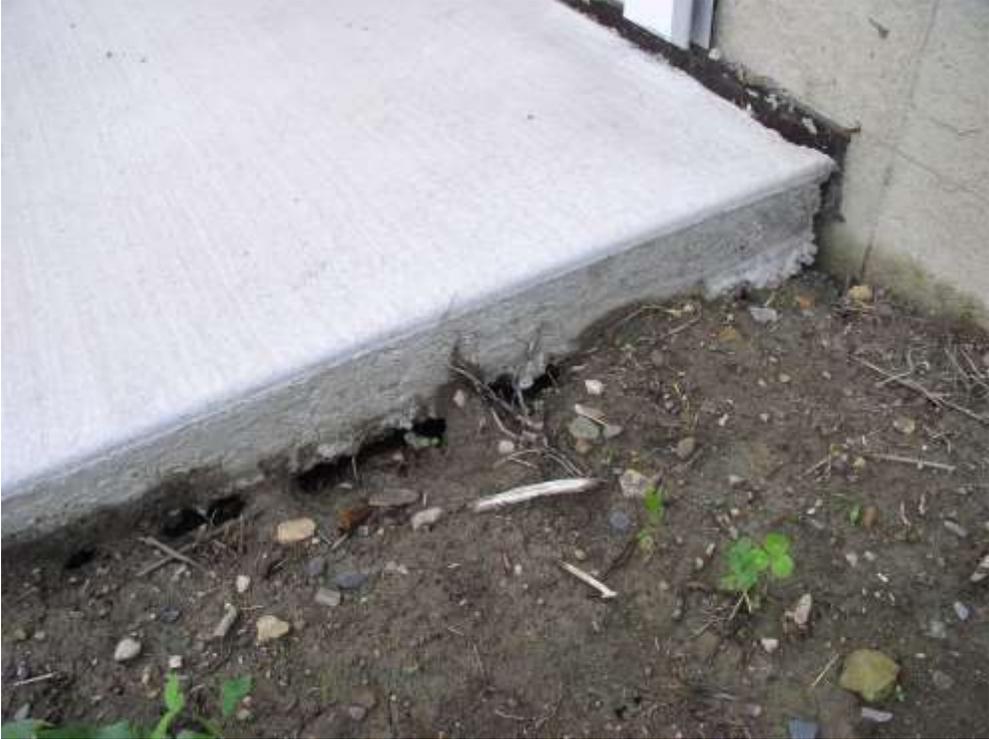
7. Driveway and related service walks, again erosion noted underneath slab near driveway where it is attached to Garage entrance pad. (see picture 3) recommend monitoring. Marginal rating.

Picture 3 driveway slab separation at garage

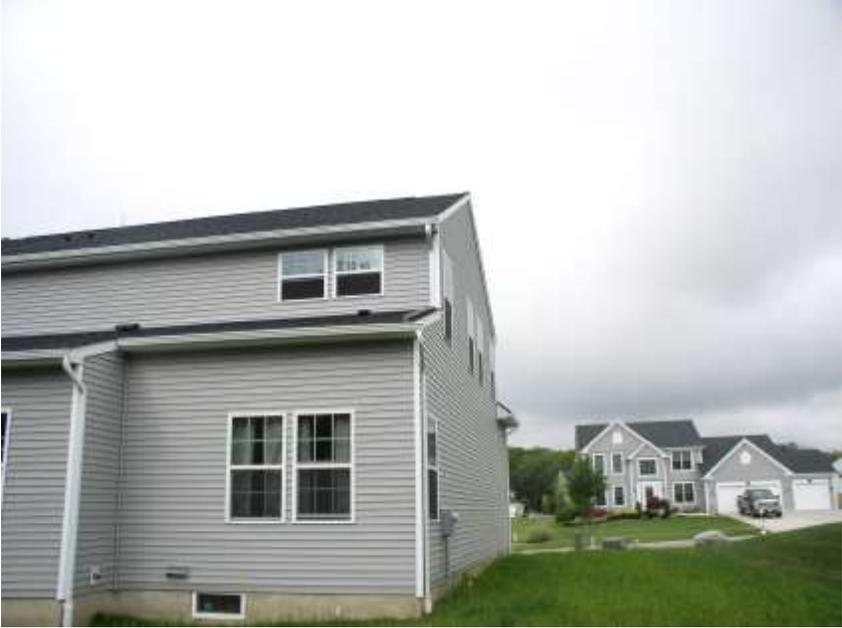
2. **Roof Drainage system is aluminum. Front roof surface has one downspout for two large roof surfaces, recommend monitoring (see picture 4).** Drainage systems is satisfactory.
3. All roof penetrations inspected from ground are satisfactory.
4. Attic/roof could not be inspected from attic because of lack of access.

Picture 4 showing roof surfaces and downspouts

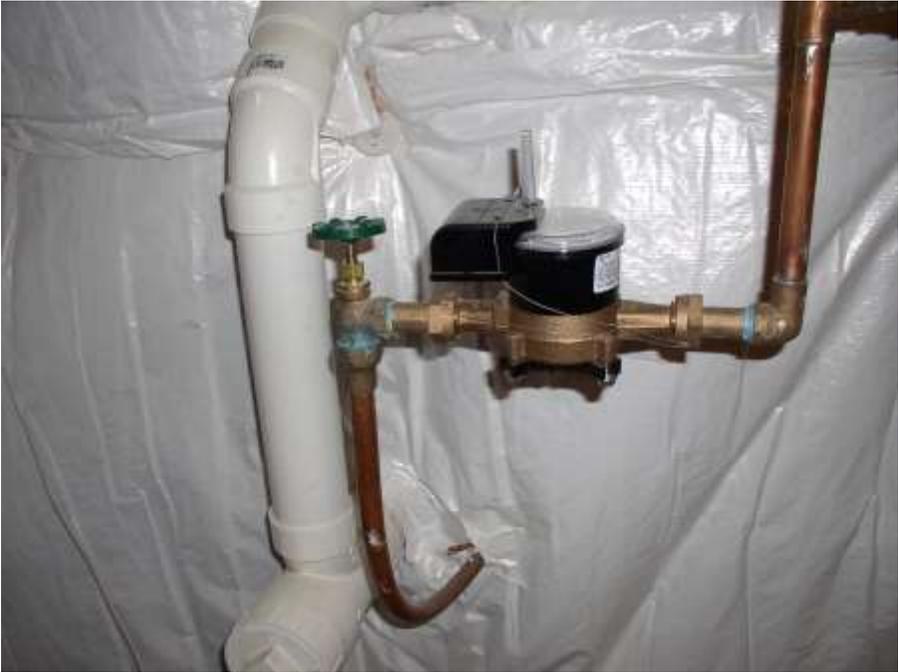
1. Interior water supply distribution systems including all faucets and fixtures; copper supply pipes municipal water source. Interior distribution plumbing is plastic. Location of main shutoff at main entrance (see picture 5) Satisfactory rating.

Picture 5 Water Main and shut off.

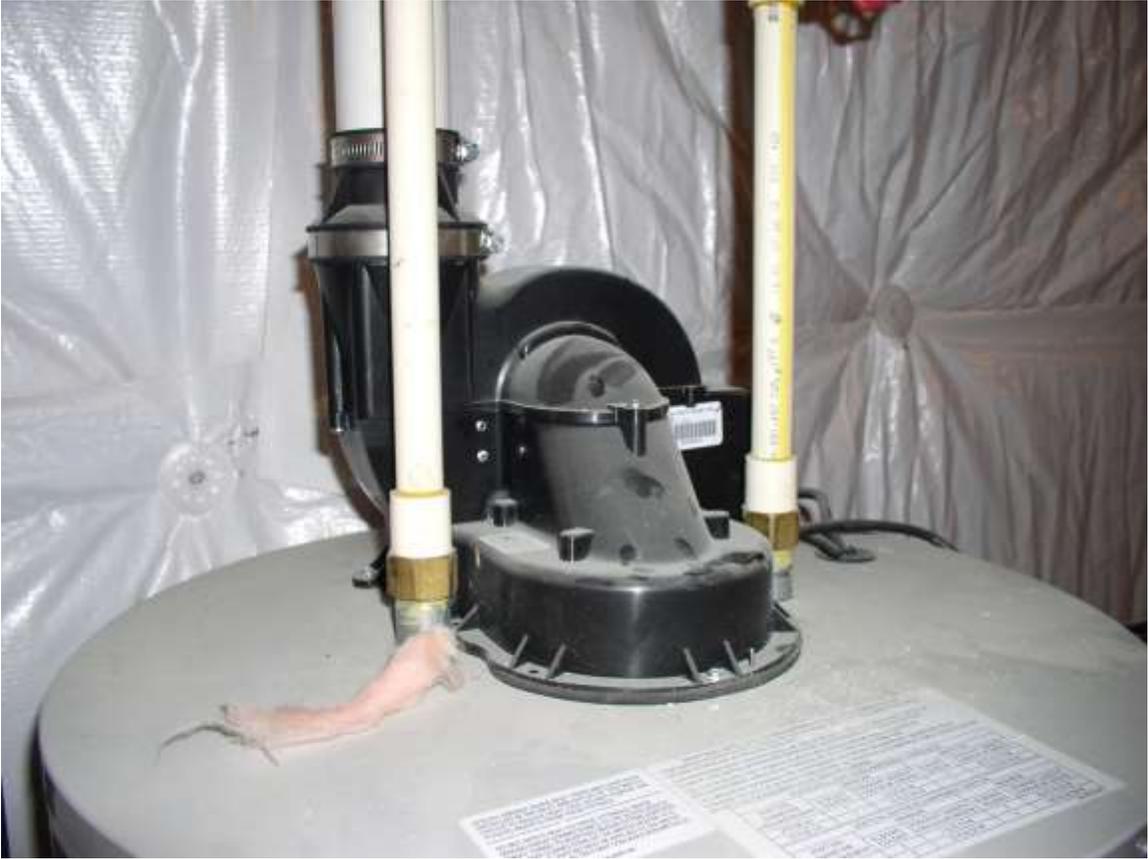
2. Hot water tank, vent systems and flues. Gas powered hot water tank with electrical venting system, vents out rear of home under deck. (See picture 6) Satisfactory rating.

Picture 6 showing operating and tested vent pump on Hot Water Tank.

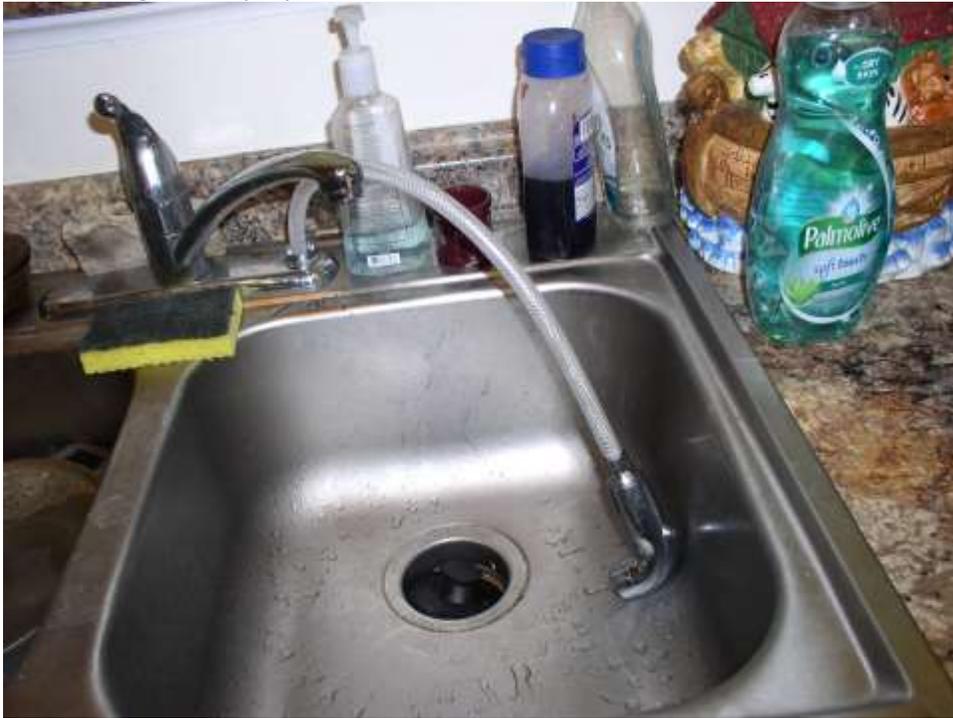
4. Sump pump noted and tested, drain noted in Basement. Satisfactory rating.
5. Overall condition of pipes support, visual inspection for cross connections and combustible piping is satisfactory. **Vegetable sprayer does not automatically retract, this could cause a cross connection, recommend evaluation by qualified plumber. (See picture 7)**

Picture7 vegetable sprayer does not retract

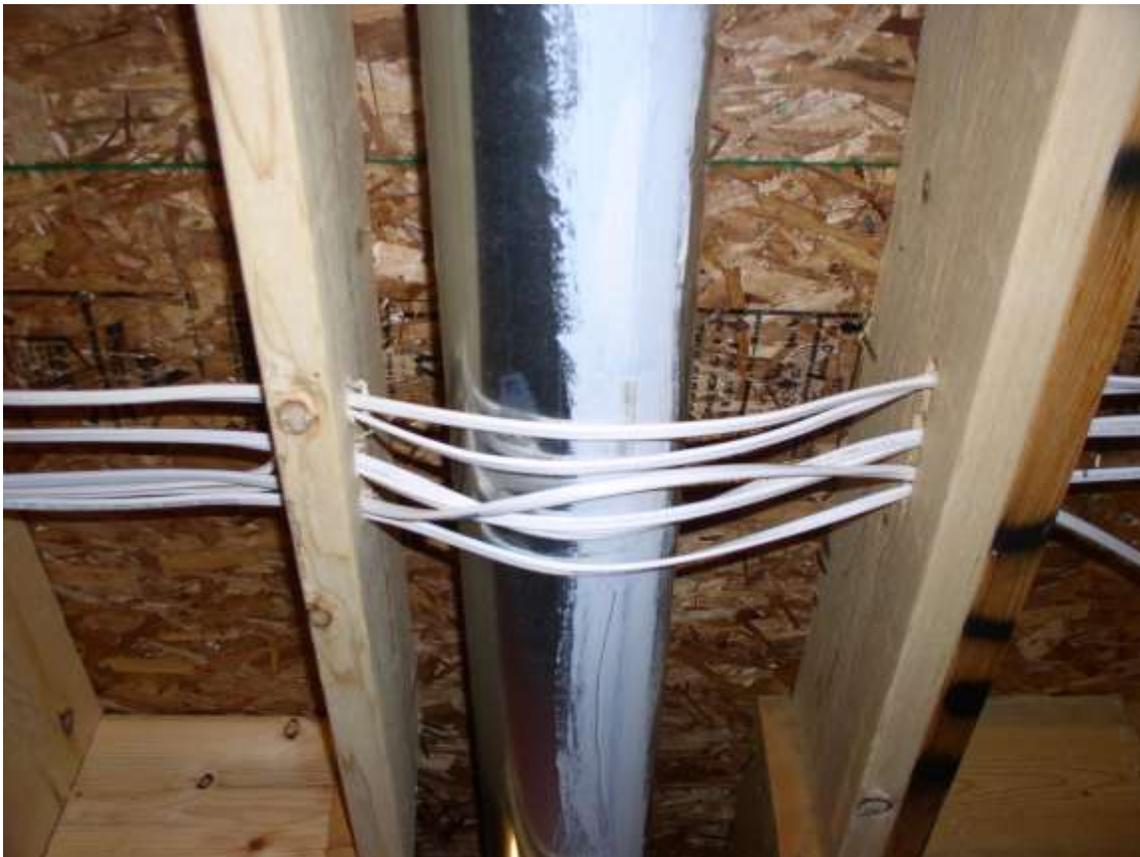
Wiring was noted to be in direct contact with heating ducts. (See Picture 8)

Picture 8 wiring direct contact with heating duct

Electric wiring should have minimum 1 inch clearance from heating ducts.

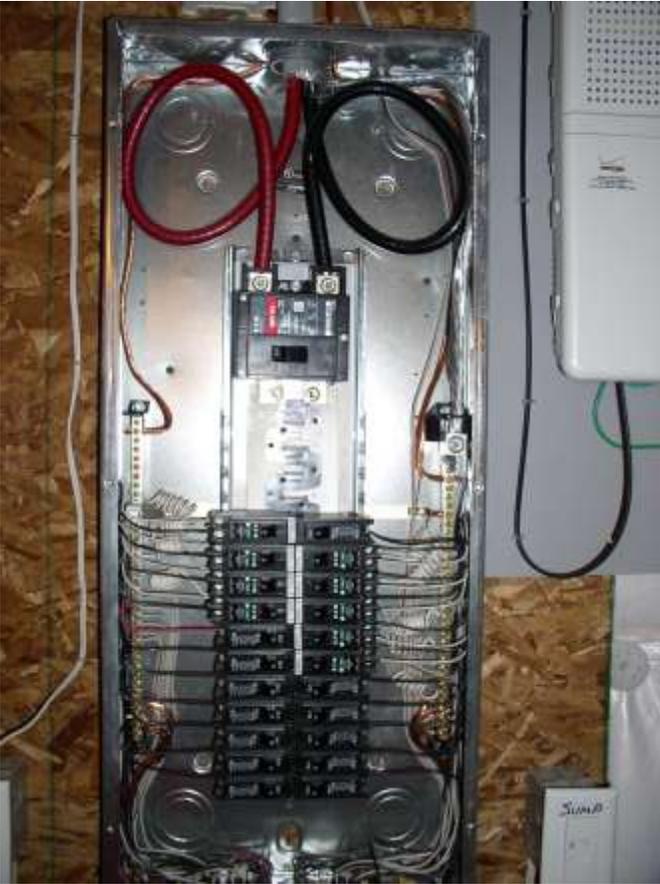
Panel is located in basement. (See picture 9) Satisfactory Rating.

Picture 9 Panel Box in basement, all wiring meets standards

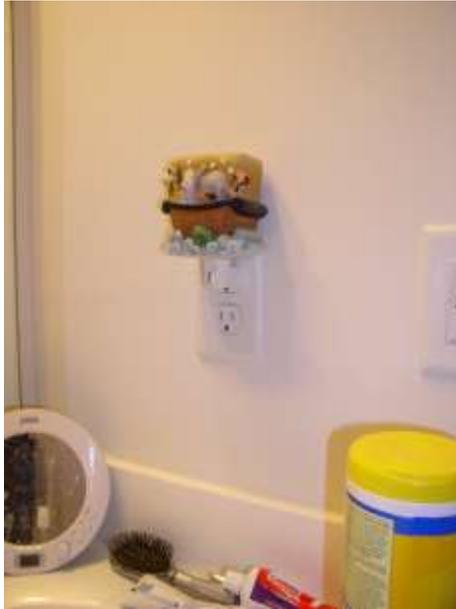
Outlet in the upstairs bathroom should be evaluated by qualified electrician, this is a safety concern. (see picture 10)

Picture 10 No GFCI
